Three-Year Reinspection Report

Peotone Elem. School
426 N. Conrad Street
Peotone, IL 60468

Peotone C.U.S.D. 207U
212 W. Wilson Street
Peotone, IL 60468

4/8/2015

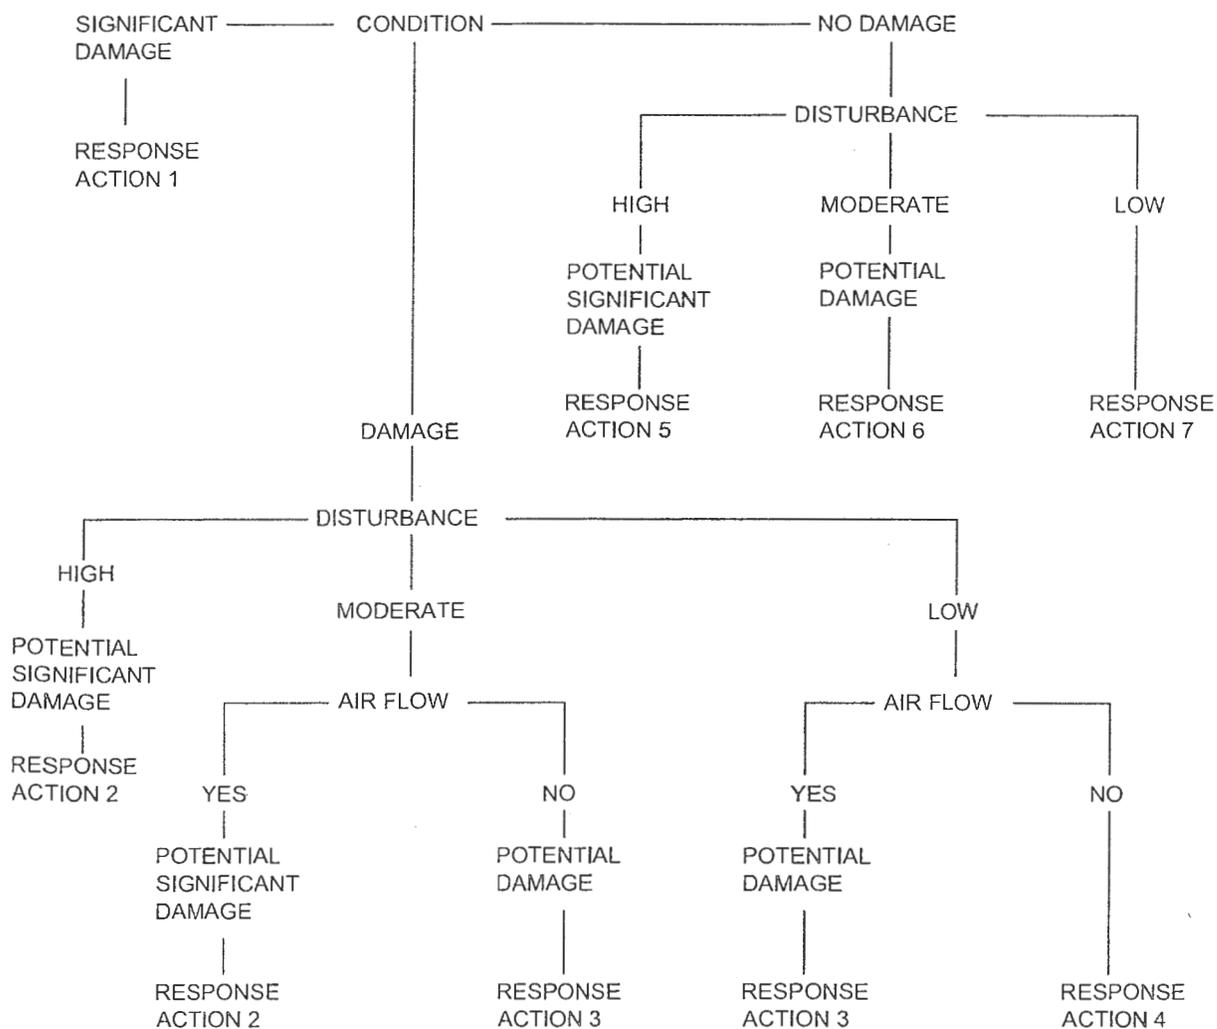
DECISION TREE - Thermal System Isulation & Friable Surfacing and Miscellaneous Materials

Response Actions and Priority for Removal:

1. FOR THERMAL SYSTEM INSULATION MATERIALS: Immediately isolate the functional space(s) which is significantly damaged and restrict access if needed. Repair all damaged materials in the functional space(s). If it is not feasible to repair, remove the damaged materials.
FOR SURFACING AND MISCELLANEOUS MATERIALS: Immediately isolate the functional space(s) which is significantly damaged and restrict access. Remove all damaged materials in the functional space, unless enclosure or encapsulation is sufficient to contain fibers.
FOR ALL ACM NOT REMOVED: Maintain ACM in good condition under O&M program.

2. Take preventative measures to reduce potential for significant damage. If preventative measures cannot be effectively implemented, isolate the area until the material can be removed, enclosed, encapsulated or repaired to correct damage. Maintain ACM in good condition under O&M program.

3. Take preventative measures to reduce likelihood further damage will occur. Remove, enclose, encapsulate or repair to correct damage. Maintain ACM in good condition under O&M program.

4. Remove, enclose, encapsulate or repair to correct damage. Maintain ACM in good condition under O&M program.
5. Take preventative measures to reduce potential for significant damage. If preventative measures cannot be effectively implemented, response actions other than O&M, including area isolation, may be required. Maintain ACM in good condition under O&M program.

6. Take preventative measures to reduce likelihood that damage will occur. Maintain ACM in good condition under O&M program.
7. Maintain ACM in good condition under O&M program.
